81MM MORTAR BASEPLATE M-3 PAD TEST

WVT-7241

AUGUST 1972

BENÉT WEAPONS LABORATORY
WATERVLIET ARSENAL
Watervliet, New York

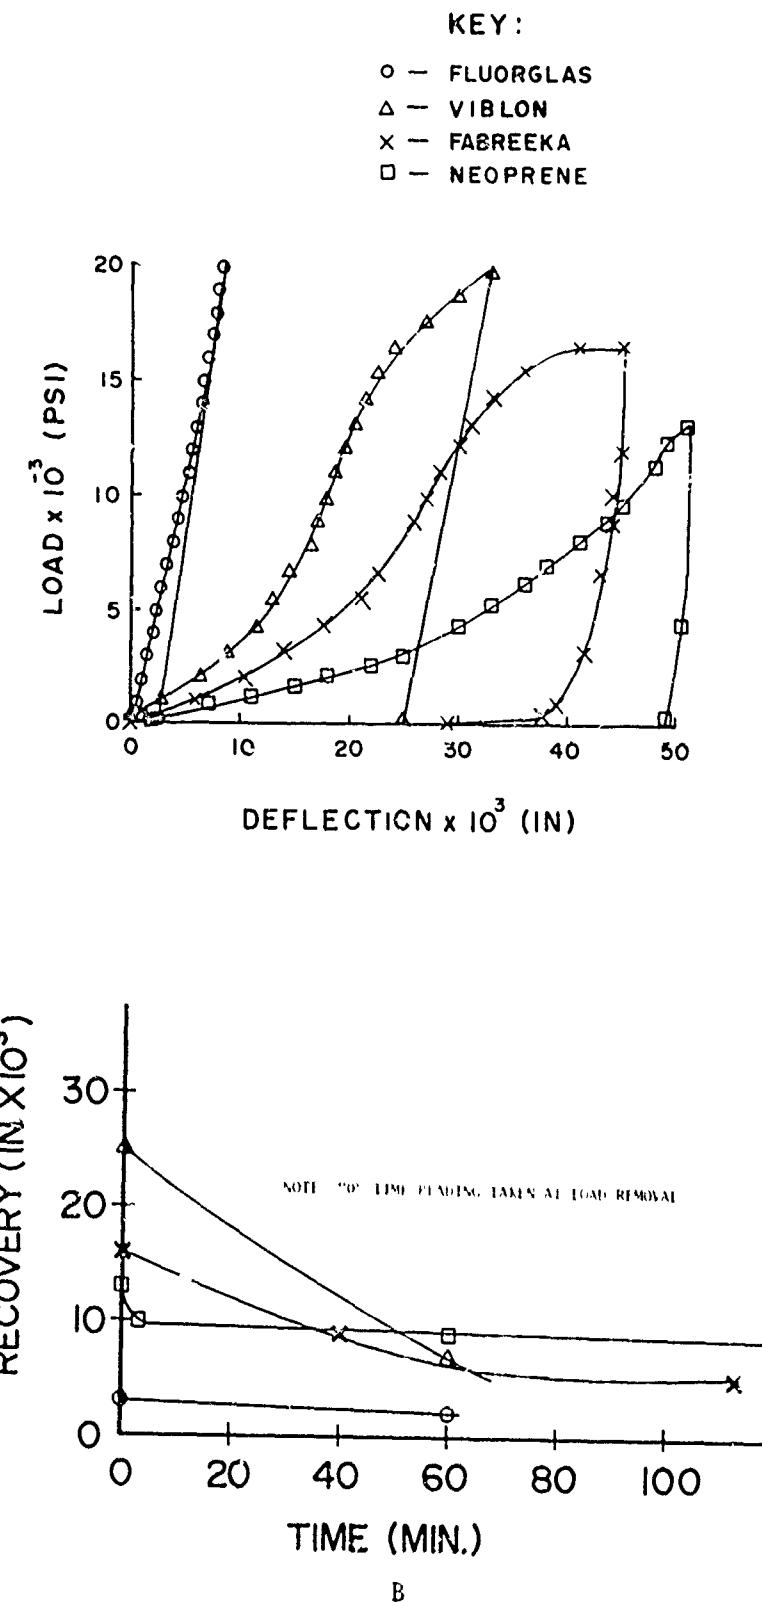
Figure 1. Pad Material Comparisons: Load Vs Deflection and Recovery Vs Time

The results of the static compression test are shown on Fig. 1 a. As would be expected, Fluorglas is shown to be approximately 4 to 5 times less deformable than the previously used Neoprene. Viblon falls about in the middle. It should be pointed out that the Fabreeka pad material more closely approximates Viblon than either Neoprene or Fluorglas. After load removal the recovery of each material was noted as a function of time, the results of which are shown on Fig. 1 b.

As can be seen from Fig. 1 b, none of the materials tested have recovery rates rapid enough to recover completely between rounds. However, Fluorglas, since it possesses the lowest permanent set and remains essentially constant with time, offers the least effect on the weapon.

During the compression tests it was found that Fluorglas was much more resistant to load than the other materials tested and also showed a much lower material set after load removal. Neoprene simply did not have enough structural strength and would delaminate under load.

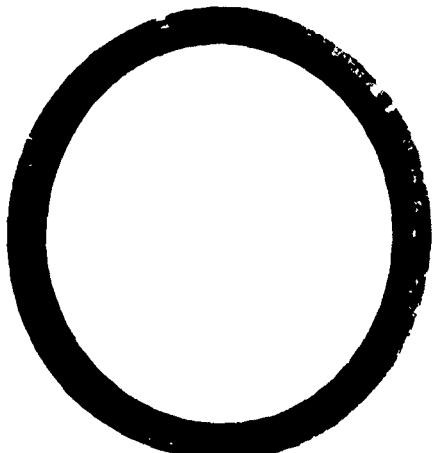
RUN 1
NEOPRENE
DRY
401 CYCLES

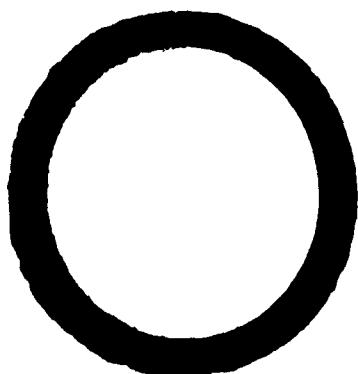
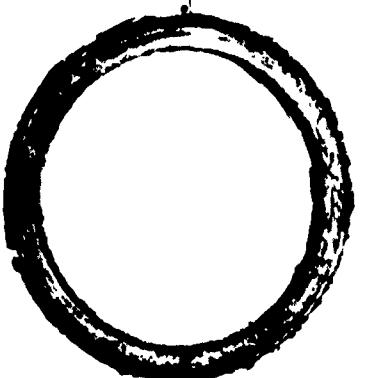
RUN 2
NEOPRENE
DRY
1000 CYCLES

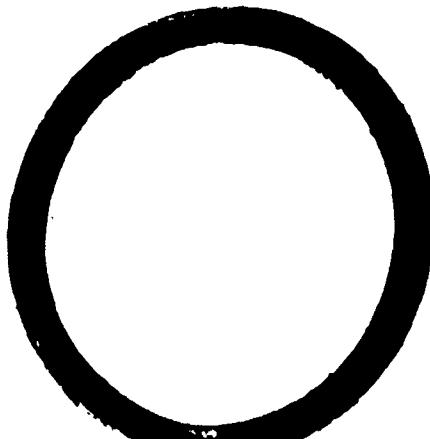
RUN 3
NEOPRENE
MUD
551 CYCLES

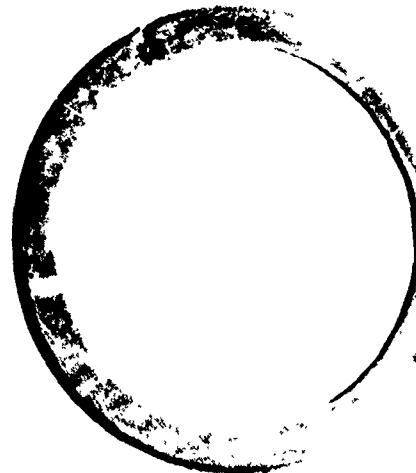
RUN 4
VIBLON (presoaked
in salt water)
MUD
100 CYCLES

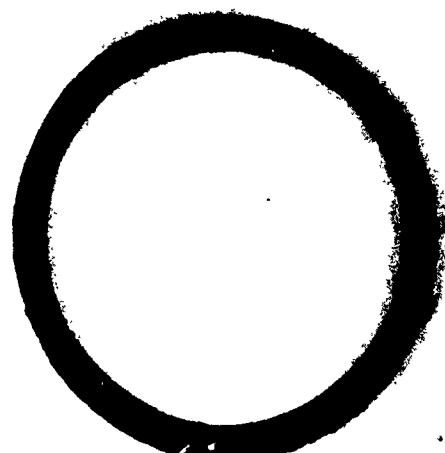
RUN 5
NEOPRENE (PRESOAKED
IN WATER)
MUD
1051 CYCLES

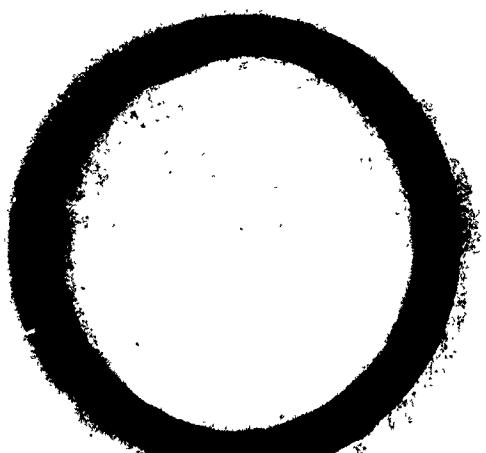
RUN 8
FLUORGLAS (PRESOAKED
IN SALT-WATER)
MUD
1001 CYCLES

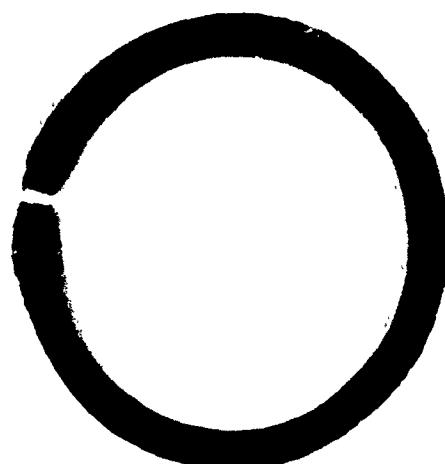
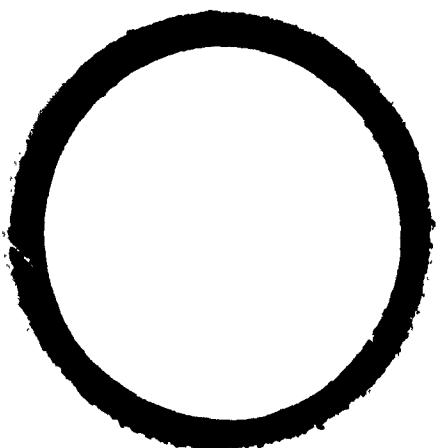
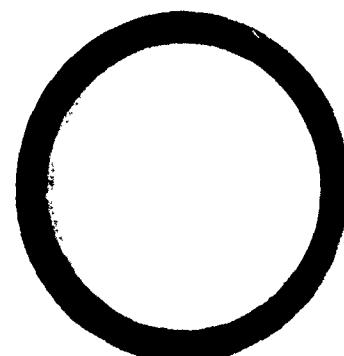
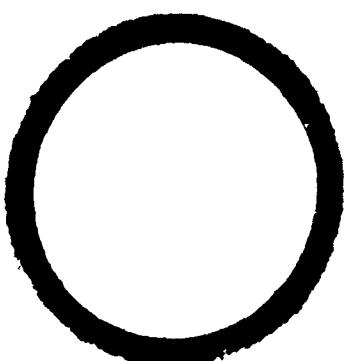
RUN 7
FLUORGLAS

MUD
1001 CYCLES

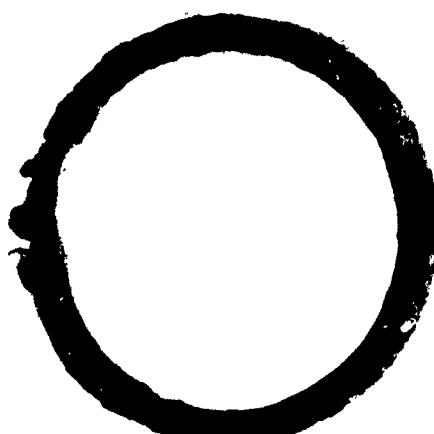
RUN 9
NEOPRENE
BUD
2001 CYCLES

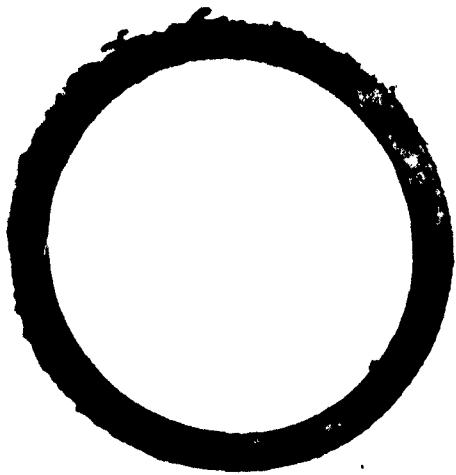
RUN 10
NEOPRENE
WET SAND (mixed)
50 CYCLES

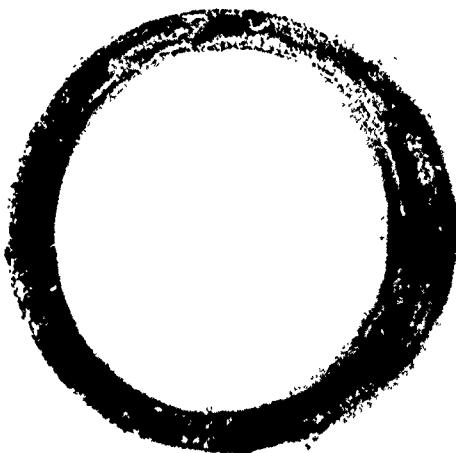
RUN 11
VIBLON
WET SAND (mixed)
1000 CYCLES

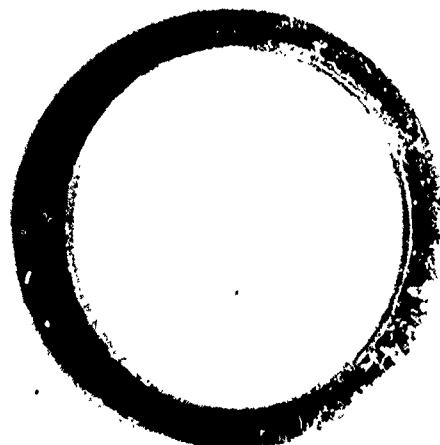
RUN 12
FLUORGLAS
WET SAND (mixed)
250 CYCLES

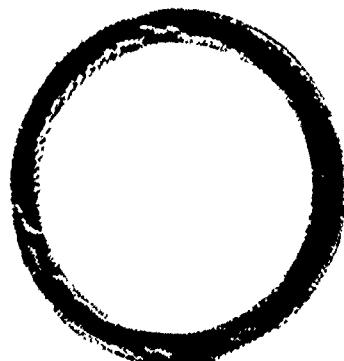
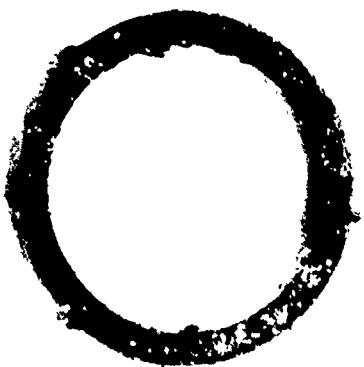
RUN 28
FLUORGAS
DRY
1001 CYCLES

RUN 29
NEOPRENE
DRY FINE SAND
1001 CYCLES

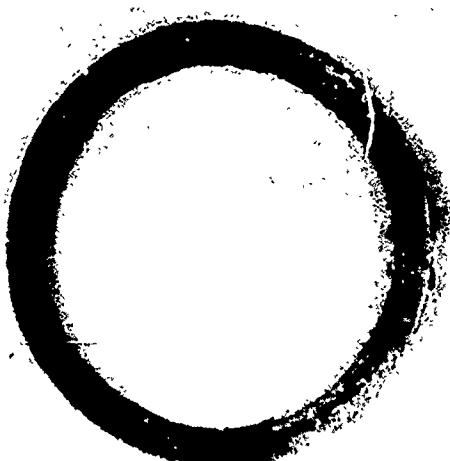
RUN 30
VIBLON
DRY FINE SAND
1001 CYCLES

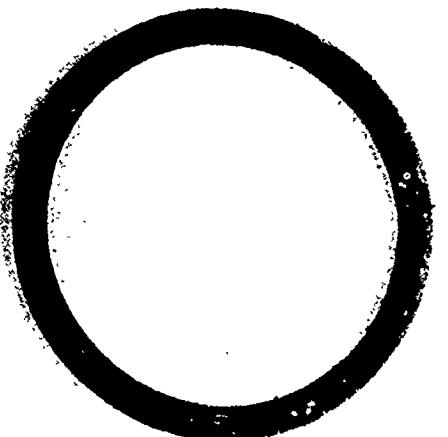
RUN 31
NEOPRENE
WET MEDIUM SAND
100 CYCLES

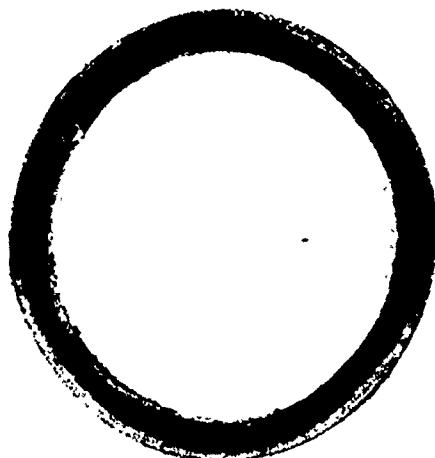
RUN 32
VIBLON
DRY
1001 CYCLES

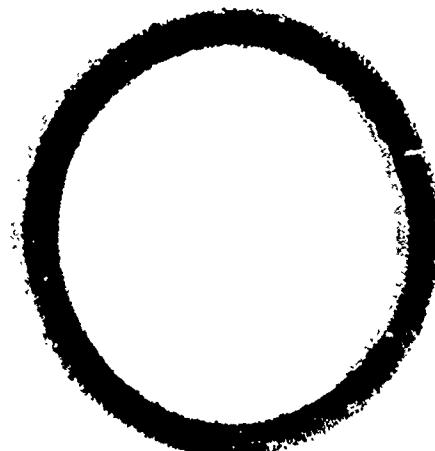
RUN 33
VIBLON
WET MEDIUM SAND
1051 CYCLES

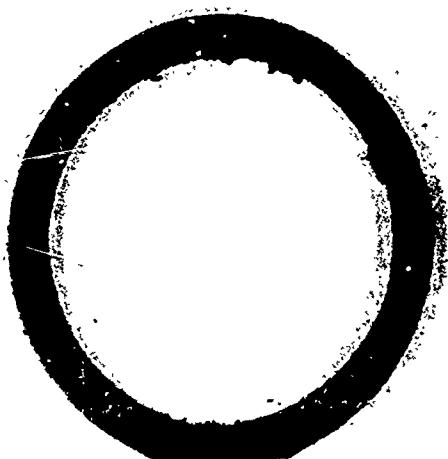
RUN 34
VIBLON
MUD
1001 CYCLES

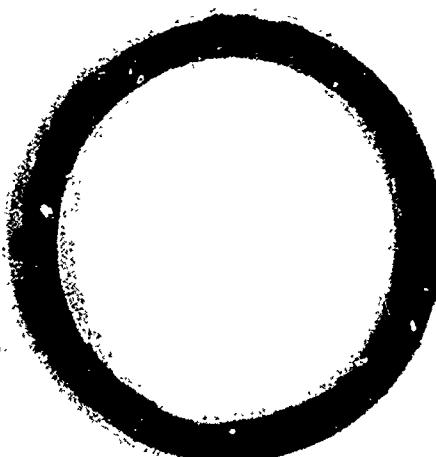
RUN 35
VIBLON
MUD, & MIXED SAND
1001 CYCLES

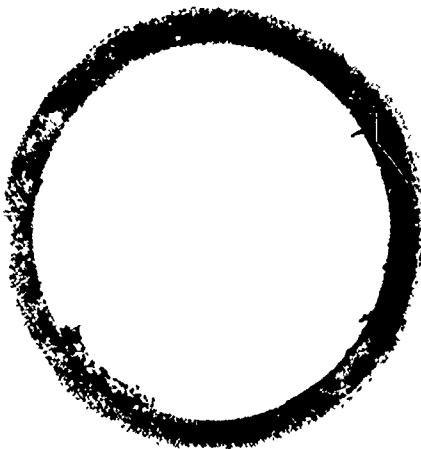
RUN 36
VIBLON (COATED
WITH GAA GREASE)
WET COARSE SAND
1001 CYCLES

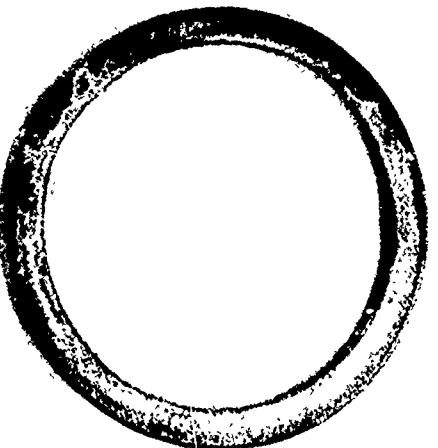
RUN 37
FLUORGLAS
WET COARSE SAND
300 CYCLES

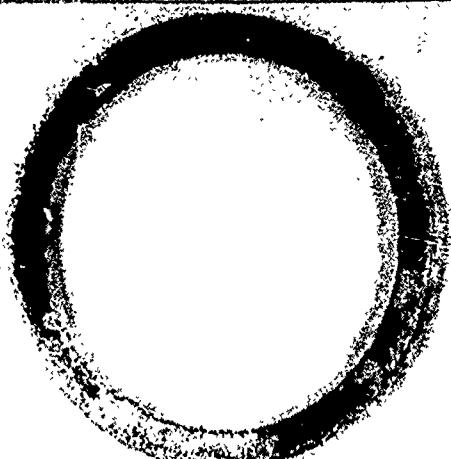
RUN 38
VIBLON (PRESOAKED
IN MIL-L-46000)
WET MIXED SAND
600 CYCLES

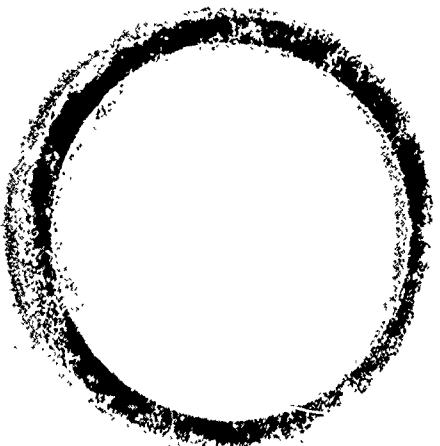
RUN 39
VIBLON (PRESOAKED
IN GAA GREASE)
WET MIXED SAND
1001 CYCLES

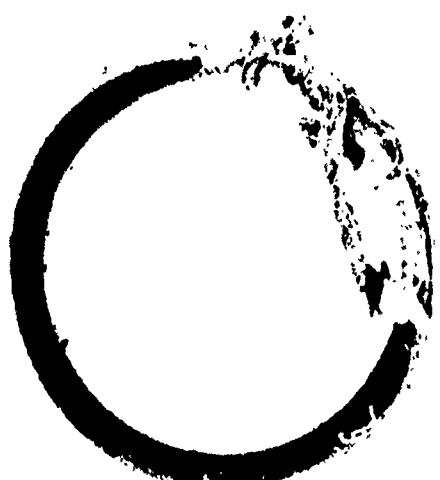
RUN 40
VIBLON - PRESOAKED
IN MIL L 46000
JET MEDIUM SAND
50 CYCLES

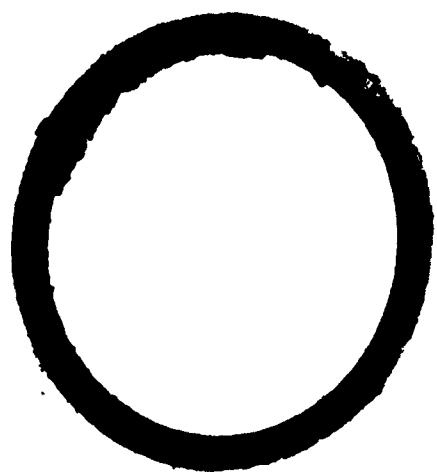
RUN 41
NEOPRENE - PRESOAKED
IN GAA GREASE
DRY COATED - 50L
130° F

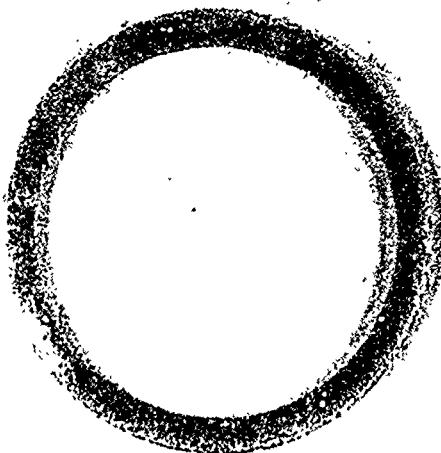
RUN 42
VIBLON (PRESOAKED
IN GAA GREASE)
WET MEDIUM SAND
1001 CYCLES

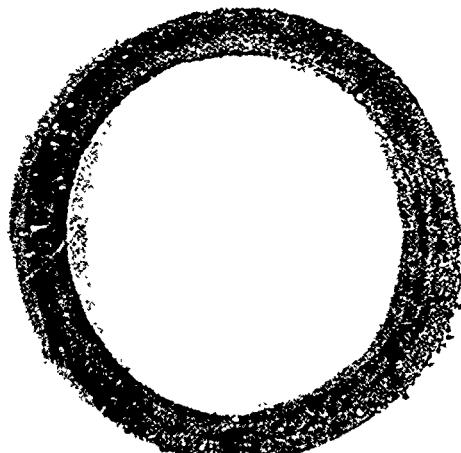
RUN 43
VIBLON (PRESOAKED
IN GAA GREASE)
DRY COARSE SAND
1001 CYCLES
